# Capillary Pathologies in Bogota's Police Museum: Parameters and Diagnosis

**Luis Carlos Galvis-Velasco**

### Abstract

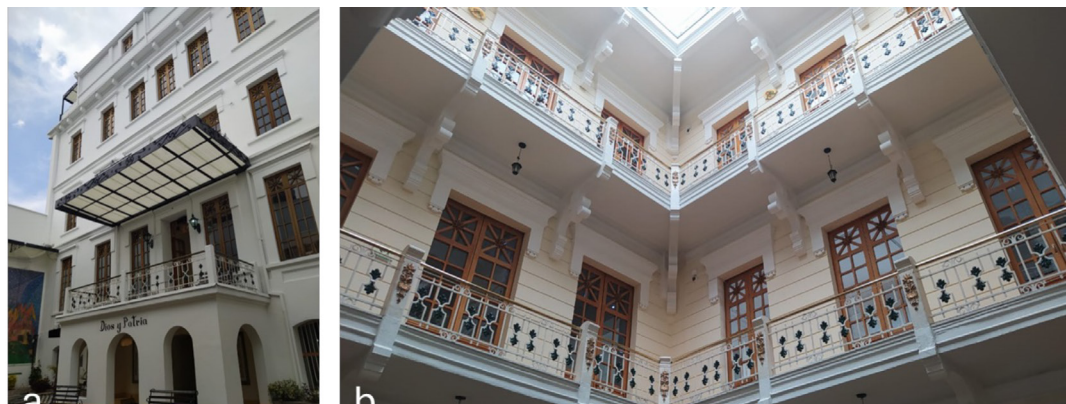
**Figure 6.** (a) Exterior Facade of the South Courtyard; (b) Interior Facades of the National Police Museum

During this inspection, five pathological processes were found on different floors of the building. These included:

1. Dampness on the facade walls, observed primarily on the eastern and western sides of the building, where water infiltration is visible on interior and exterior surfaces
2. Dampness on the walls and ceilings of the exhibition halls, affecting several rooms on the second and third floors, resulting in discoloration and peeling paint
3. Dampness on the tongue-and-groove ceiling of the fourth floor, seen in the central part of the ceiling, where moisture marks have developed along the wood panels
4. Dampness in the basement walls, particularly along the northern section, leading to notable deterioration and musty odors
5. Cracks in the basement walls, located near support columns and along the southeast wall, which may impact structural integrity and require further assessment

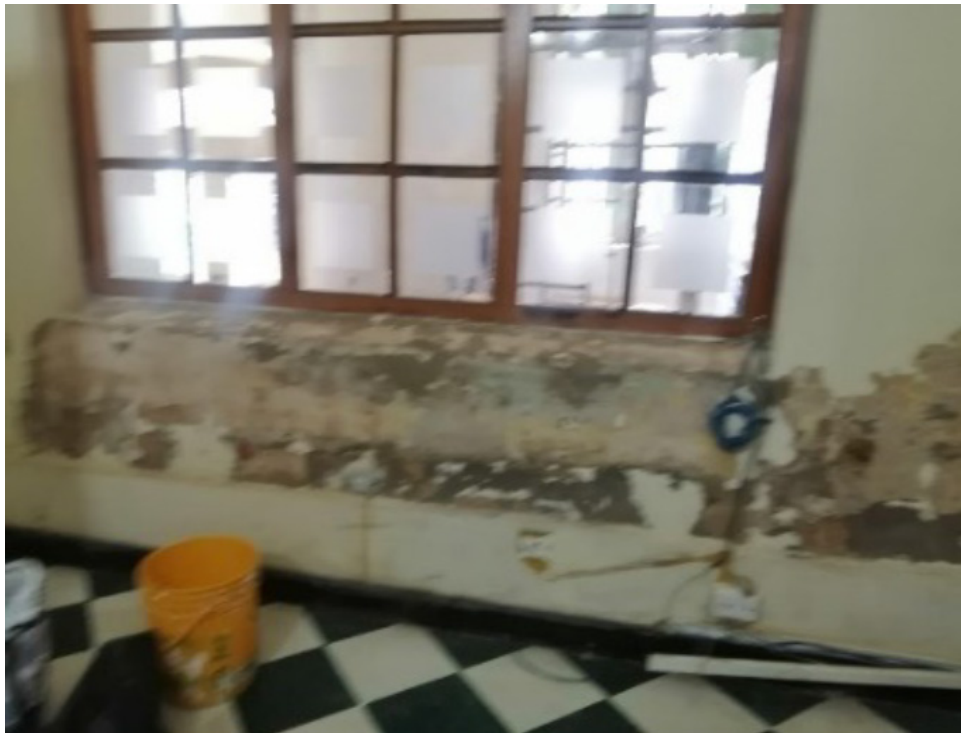
**Figure 7.** Capillary Moisture

The basement walls showed evidence of moisture from capillary rise from the subsoil, manifested as surface staining, detachment of finishing materials, and cracking. This pathological process also led to malodorous conditions within the affected spaces. Primary physical damage was manifested through expansion or fissuring at the interfaces between structural elements, thereby facilitating the upward migration of moisture. Secondary physical damage was attributable to the absence of a foundational design that incorporated effective isolation from the subgrade, thereby precluding capillary rise of groundwater or soil moisture [39].

The issue was identified as capillary moisture in the basement walls, caused by water rising from the ground. This process caused the finished material to peel and flake and produced unpleasant odors due to persistent moisture. Capillarity was observed as water was absorbed by the brick due to its inherent porosity (Figure 7).

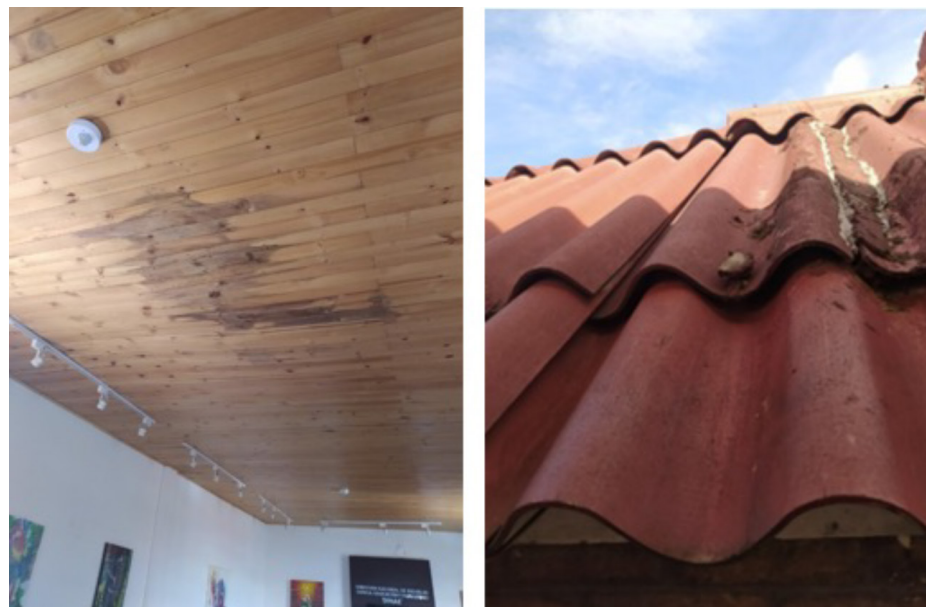
**Figure 8.** Moisture Due to Absorption

The ceiling joists absorbed water from a leak in the sloped roof. The deterioration and standard repair of the roofing system allowed rainwater infiltration, resulting in progressive rot and degradation of the timber ceiling components. Verification was conducted to ascertain whether the roof structure was indeed composed of wood and to evaluate the extent of its deterioration [38]. The primary physical damage was a fissure in the roofing system, which facilitated water ingress and subsequent moisture accumulation within the timber elements affected by the leak. While the secondary physical damage was further exacerbated by the absence of preventive maintenance and the implementation of inadequate repair interventions [39].

The ceiling material on the fourth floor of the building absorbed water from a leak in the sloped roof; cracks in the roof tiles were attributed to material deterioration or structural movements caused by settlement. A comprehensive inspection was undertaken to determine whether the roof structure comprised timber or metal and to evaluate the extent of moisture-induced deterioration. A combination of visual inspections (to detect staining, warping, and visible damage), non-destructive moisture meter testing, and core sampling in discreet areas was employed to ascertain the condition and typology of the roof support structure. For settlement assessment, visual crack mapping was performed, crack meters and telltales were installed to monitor ongoing structural movement, and, where feasible, level surveys were conducted to identify differential settlements across the structure. These settlement examinations were essential for verifying the building's structural condition, especially given the absence of historical documentation [40].

A section of the ceiling was removed to identify the material of the roof support structure and to determine whether it was affected by moisture. Inspection of the entire building enabled assessment of additional cracks and determined whether the basement crack extended to the uppermost floor (Figure 8).

With respect to the moisture identified on the fourth floor within the exhibition area, remedial actions included replacing fractured roof tiles and strategically removing a segment of the ceiling to facilitate direct inspection of the underlying roof structure, which is presumed to be timber, given the building's historical context. Where moisture-induced deterioration of the wooden structural components was corroborated, restoration or substitution of compromised

elements was undertaken to reestablish structural soundness. Furthermore, the installation of comprehensive waterproofing and protective systems was planned to mitigate the risk of recurrent moisture intrusion in this area.

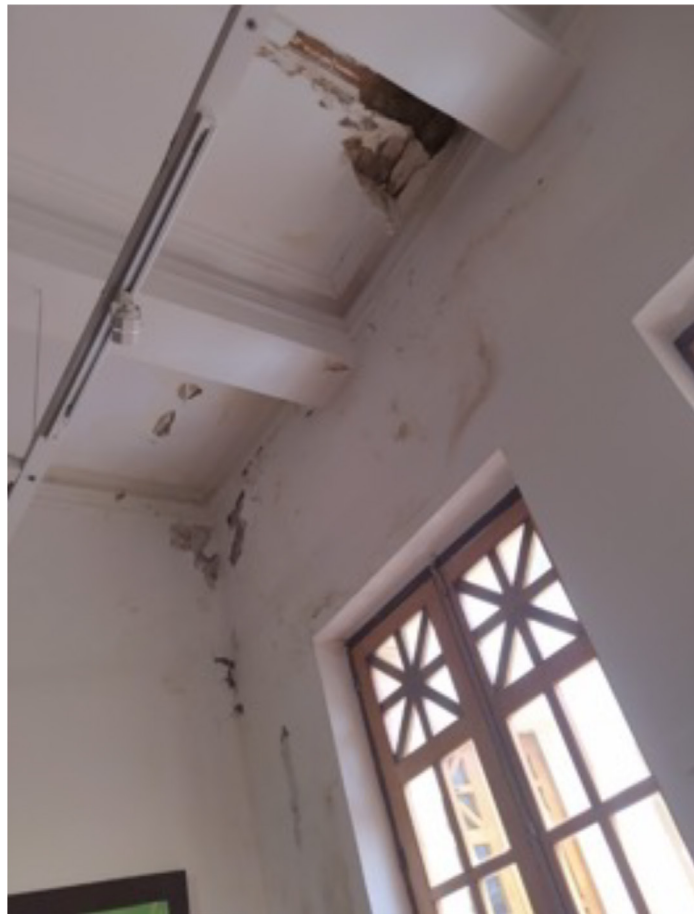
**Figure 9.** Moisture Due to Water Infiltration

In the ceiling and interior wall of the third-floor exhibition hall, there is a slab from the fourth floor finished with vitrified tiles. The slab was not waterproofed prior to this finish, so rainwater and water from building cleaning seep in. The water seeps in at the junction of the wall and the slab; it is also possible that the construction materials have a high degree of absorbency, all of which causes moisture in the walls and deterioration of the ceiling finish, leading to peeling. Remediation steps may include waterproofing the slab to prevent further water infiltration, repairing damaged ceiling finishes, and replacing any highly absorbent construction materials with more moisture-resistant alternatives. Proper sealing of the junctions between walls and slabs should also be considered to ensure durable repair [37].

Moisture was observed on the third floor, where the slab lacked the requisite waterproofing, attributable to either a construction error or a design flaw. This condition caused expansion at the wall-slab joint, thereby facilitating rainwater infiltration into the exhibition halls. The brickwork absorbed infiltrated water due to its inherent porosity (Figure 9).

A watertightness test was conducted on the fourth-floor slab to determine whether the moisture originated from rainwater infiltration or water used for floor maintenance, thereby confirming the absence of waterproofing. The test followed procedures outlined in industry standards, such as ASTM E514, which involved flooding the slab with water for a specified duration and monitoring the underside for signs of leakage or dampness. Prior to testing, drainage outlets were temporarily sealed, and observations were recorded at designated intervals to ensure a consistent and reliable assessment of waterproofing performance. A sample was taken from the moisture-affected wall to determine the degree of absorption of the wall materials and to establish the thickness of the plaster.

A moisture meter was employed to determine the moisture content of the materials. Additionally, analyses were conducted during both dry and rainy seasons to verify moisture behavior—specifically, whether it increased, decreased, or remained stable over time.

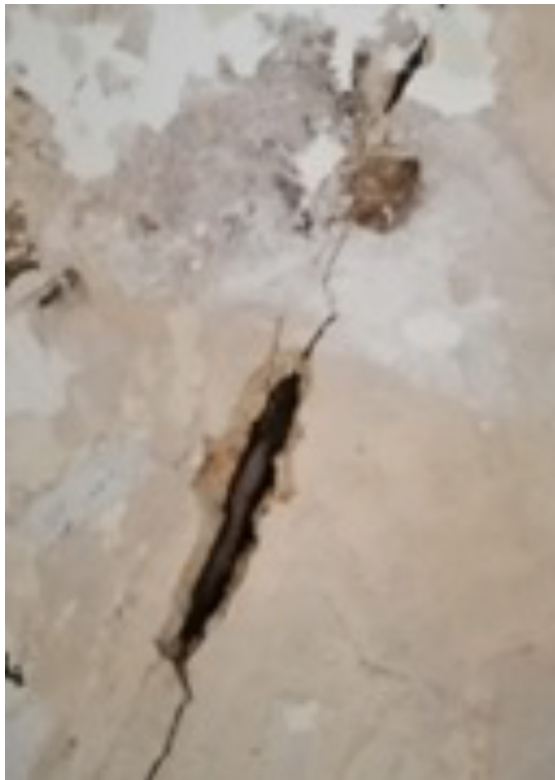
**Figure 11.** Crack Due to Settlement

The basement walls exhibited fissures that were primarily attributable to differential settlement of the building, though the contribution of capillary moisture—leading to the progressive weakening and disintegration of the masonry—could not be excluded. The fissures were predominantly vertical, originating at the floor and extending upward, with greater severity in zones with marked moisture ingress. A comprehensive crack-mapping campaign was undertaken, including precise measurements of crack width, length, and orientation. The spatial distribution and severity of these fissures were rigorously documented to elucidate primary etiological factors and inform the formulation of effective remediation strategies.

Cracks in the basement walls may have been caused by differential settlement of the building or by water rising due to capillary action or groundwater, resulting in swelling and subsequent cracking of the material. Settlement monitoring was undertaken to determine the condition of the structure. Crack gauges (crack meters) were installed across identified cracks in the basement walls to monitor crack width and progression over time. Additionally, periodic visual surveys and precise level surveys were scheduled to document any changes in elevation or new crack formations, thereby facilitating the identification of ongoing or new settlement. These monitoring activities were planned at regular intervals to ensure timely detection and intervention.

In the damp basement, measurements were taken with a crack meter to assess crack activity and dimensions. A soil study was conducted to determine the soil characteristics, groundwater table, and bearing capacity. Given that the basement exhibited cracks, it was essential to perform the structural analysis (Figure 11).
