# Capillary Pathologies in Bogota's Police Museum: Parameters and Diagnosis

**Received:** 3 de junio de 2026; **Evaluated:** 17 de junio de 2026; **Accepted:** 24 de julio de 2026

**Luis Carlos Galvis-Velasco**

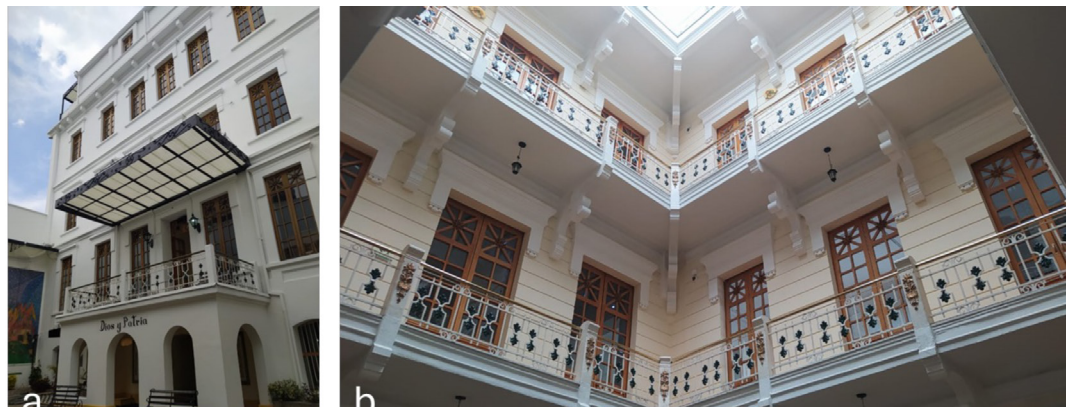
**Figure 6.** (a) Exterior Facade of the South Courtyard; (b) Interior Facades of the National Police Museum

During this inspection, five pathological processes were found on different floors of the building. These included:

1. Dampness on the facade walls, observed primarily on the eastern and western sides of the building, where water infiltration is visible on interior and exterior surfaces

2. Dampness on the walls and ceilings of the exhibition halls, affecting several rooms on the second and third floors, resulting in discoloration and peeling paint
3. Dampness on the tongue-and-groove ceiling of the fourth floor, seen in the central part of the ceiling, where moisture marks have developed along the wood panels
4. Dampness in the basement walls, particularly along the northern section, leading to notable deterioration and musty odors
5. Cracks in the basement walls, located near support columns and along the southeast wall, which may impact structural integrity and require further assessment

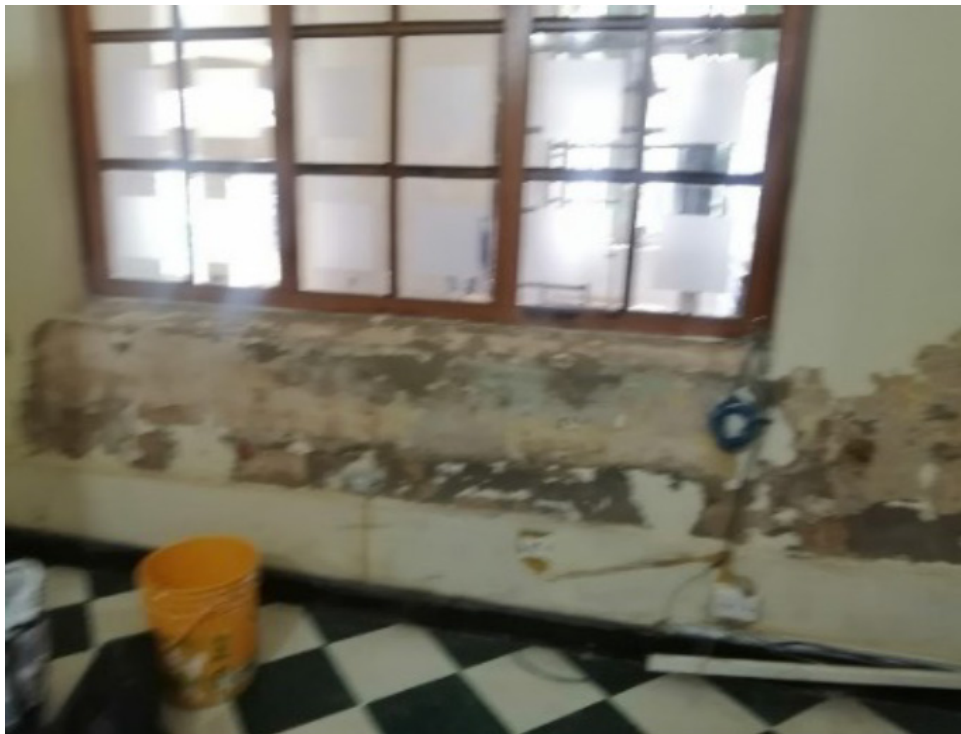
**Figure 7.** Capillary Moisture

The basement walls showed evidence of moisture from capillary rise from the subsoil, manifested as surface staining, detachment of finishing materials, and cracking. This pathological process also led to malodorous conditions within the affected spaces. Primary physical damage was manifested through expansion or fissuring at the interfaces between structural elements, thereby facilitating the upward migration of moisture. Secondary physical damage was attributable to the absence of a foundational design that incorporated effective isolation from the subgrade, thereby precluding capillary rise of groundwater or soil moisture [39].

The issue was identified as capillary moisture in the basement walls, caused by water rising from the ground. This process caused the finished material to peel and flake and produced unpleasant odors due to persistent moisture. Capillarity was observed as water was absorbed by the brick due to its inherent porosity (Figure 7).

The pathological processes identified in the preliminary diagnosis were further delineated through material analysis to determine the extent of absorption in the affected materials. Soil samples were collected for geotechnical testing to establish the groundwater table. Based on the results of these analyses, the most suitable repair methods and mitigation strategies were identified, including selecting appropriate waterproofing systems, improving drainage around the building, and replacing compromised materials. This step facilitated the establishment of necessary resources, the prioritization of actions, and the creation of a realistic timeline for implementing repairs.

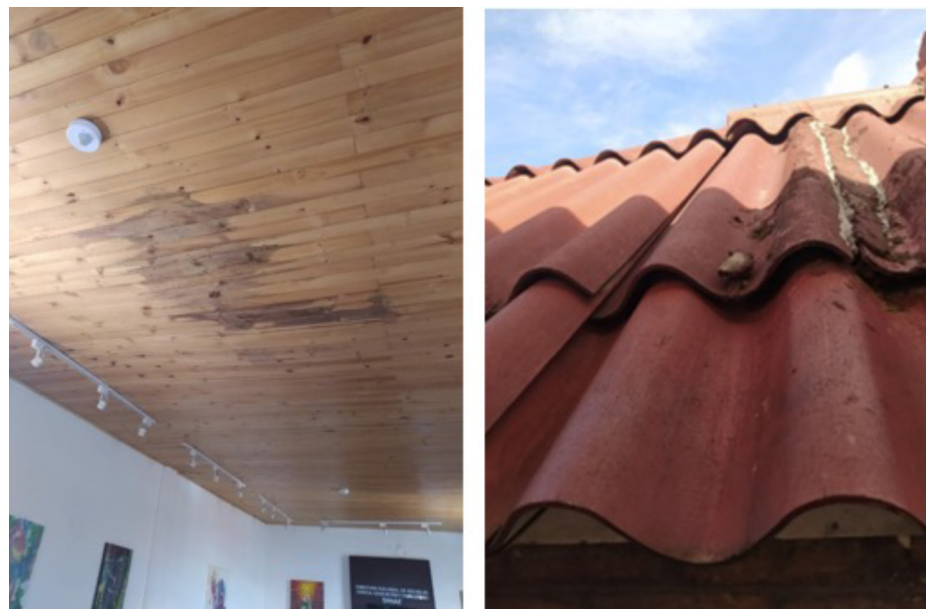
**Figure 8.** Moisture Due to Absorption

The ceiling joists absorbed water from a leak in the sloped roof. The deterioration and standard repair of the roofing system allowed rainwater infiltration, resulting in progressive rot and degradation of the timber ceiling components. Verification was conducted to ascertain whether the roof structure was indeed composed of wood and to evaluate the extent of its deterioration [38]. The primary physical damage was a fissure in the roofing system, which facilitated water ingress and subsequent moisture accumulation within the timber elements affected by the leak. While the secondary physical damage was further exacerbated by the absence of preventive maintenance and the implementation of inadequate repair interventions [39].

A section of the ceiling was removed to identify the material of the roof support structure and to determine whether it was affected by moisture. Inspection of the entire building enabled assessment of additional cracks and determined whether the basement crack extended to the uppermost floor (Figure 8).

With respect to the moisture identified on the fourth floor within the exhibition area, remedial actions included replacing fractured roof tiles and strategically removing a segment of the ceiling to facilitate direct inspection of the underlying roof structure, which is presumed to be timber, given the building's historical context. Where moisture-induced deterioration of the wooden structural components was corroborated, restoration or substitution of compromised elements was undertaken to reestablish structural soundness. Furthermore, the installation of comprehensive waterproofing and protective systems was planned to mitigate the risk of recurrent moisture intrusion in this area.

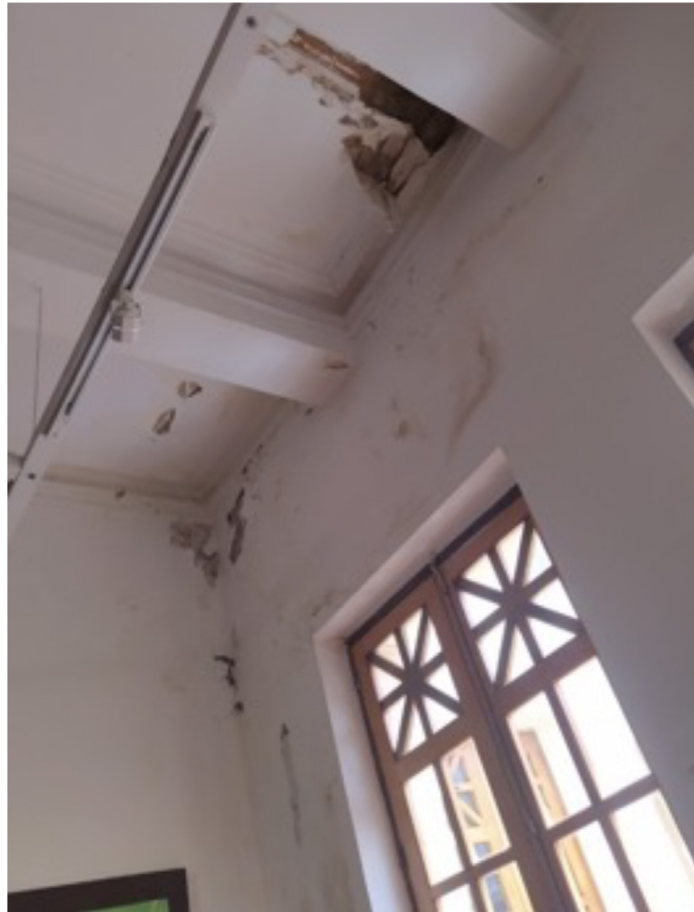
**Figure 9.** Moisture Due to Water Infiltration

In the ceiling and interior wall of the third-floor exhibition hall, there is a slab from the fourth floor finished with vitrified tiles. The slab was not waterproofed prior to this finish, so rainwater and water from building cleaning seep in. The water seeps in at the junction of the wall and the slab; it is also possible that the construction materials have a high degree of absorbency, all of which causes moisture in the walls and deterioration of the ceiling finish, leading to peeling. Remediation steps may include waterproofing the slab to prevent further water infiltration, repairing damaged ceiling finishes, and replacing any highly absorbent construction materials with more moisture-resistant alternatives. Proper sealing of the junctions between walls and slabs should also be considered to ensure durable repair [37].

Moisture was observed on the third floor, where the slab lacked the requisite waterproofing, attributable to either a construction error or a design flaw. This condition caused expansion at the wall-slab joint, thereby facilitating rainwater infiltration into the exhibition halls. The brickwork absorbed infiltrated water due to its inherent porosity (Figure 9).

A watertightness test was conducted on the fourth-floor slab to determine whether the moisture originated from rainwater infiltration or water used for floor maintenance, thereby confirming the absence of waterproofing. The test followed procedures outlined in industry standards, such as ASTM E514, which involved flooding the slab with water for a specified duration and monitoring the underside for signs of leakage or dampness. Prior to testing, drainage outlets were temporarily sealed, and observations were recorded at designated intervals to ensure a consistent and reliable assessment of waterproofing performance. A sample was taken from the moisture-affected wall to determine the degree of absorption of the wall materials and to establish the thickness of the plaster.

A moisture meter was employed to determine the moisture content of the materials. Additionally, analyses were conducted during both dry and rainy seasons to verify moisture behavior—specifically, whether it increased, decreased, or remained stable over time.

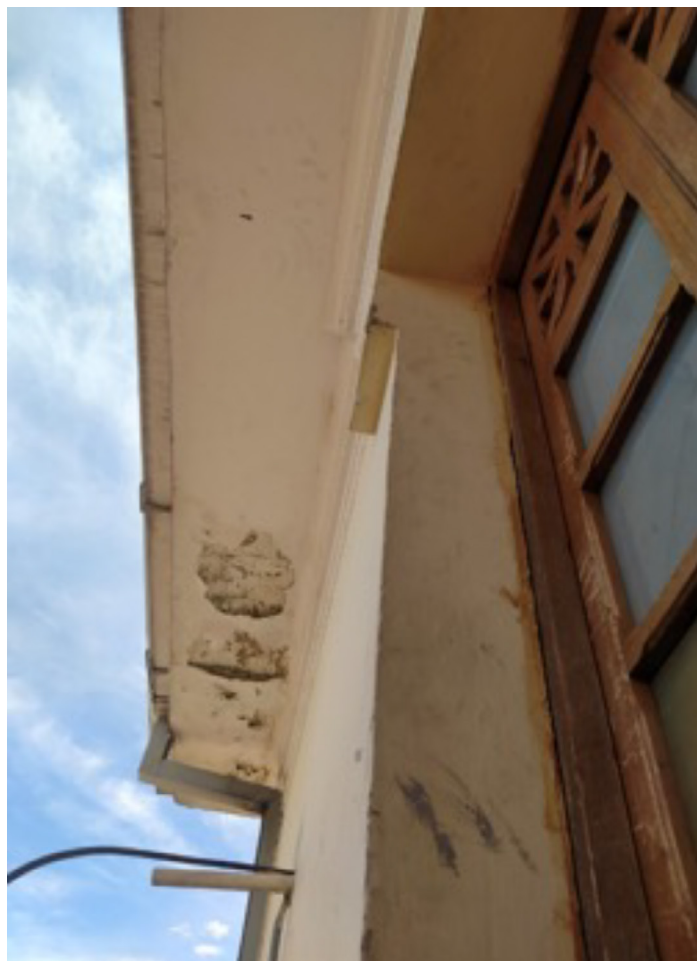
**Figure 10.** Moisture Due to Atmospheric Conditions

The facade walls exhibited staining and detachment of surface finishes, attributable to environmental moisture and direct precipitation. These pathological changes were exacerbated by architectural features that promoted water accumulation and hindered effective drainage in localized areas of the facade. Further analysis was required to determine the adequacy of construction materials and the presence or absence of waterproofing measures. Primary physical damage was primarily caused by direct exposure of facade elements, the development of efflorescence, and persistent moisture infiltration. Secondary physical damage resulted from architectural designs that impeded proper rainwater drainage, insufficient preventive maintenance, or the implementation of suboptimal repair strategies [39].

Due to the architectural design, certain areas allowed water to stagnate; this water penetrated the existing material, inducing moisture and detachment of the facade finish. It was also possible that the facade was not waterproof, a deficiency attributable either to a construction error or a design flaw (Figure 10).

Material sampling was conducted in the moisture-impacted sections of the wall to evaluate the absorptive properties of the construction materials and to ascertain the thickness of the applied render.
