# Structural Pathology and Seismic Vulnerability in Community Infrastructure: The Case of the Women's Social Center in Cota, Colombia

This paper assesses the structural condition and vulnerability of the Women's Social Center, a single-story building with about 208 m<sup>2</sup> of floor area in Cota, Cundinamarca. The research, conducted under Contract SIOP-CM-006-2023, aims to assess the building's condition and verify the technical feasibility of vertical expansion, in accordance with the Colombian Code for Seismic-Resistant Construction (NSR-10). The meth-

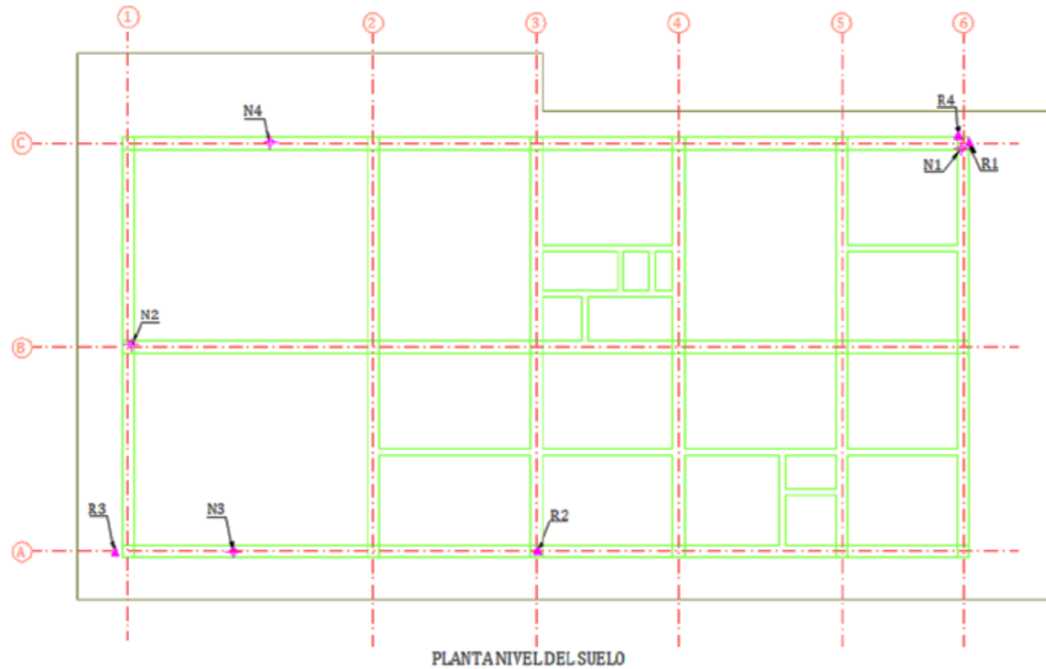
**Figure 6.** Location Plan of the Extracted Core Samples and the Field Tests Carried Out in the Existing Area Distribution Plan

During the visual inspection, the structure appeared to be in good condition. No significant pathologies were found, aside from some cracks in non-structural elements, which are presumed to be due to seismic activity over the building's lifespan. Additionally, we performed various tests to determine the condition of the existing structure; these tests are shown in Figure 6.

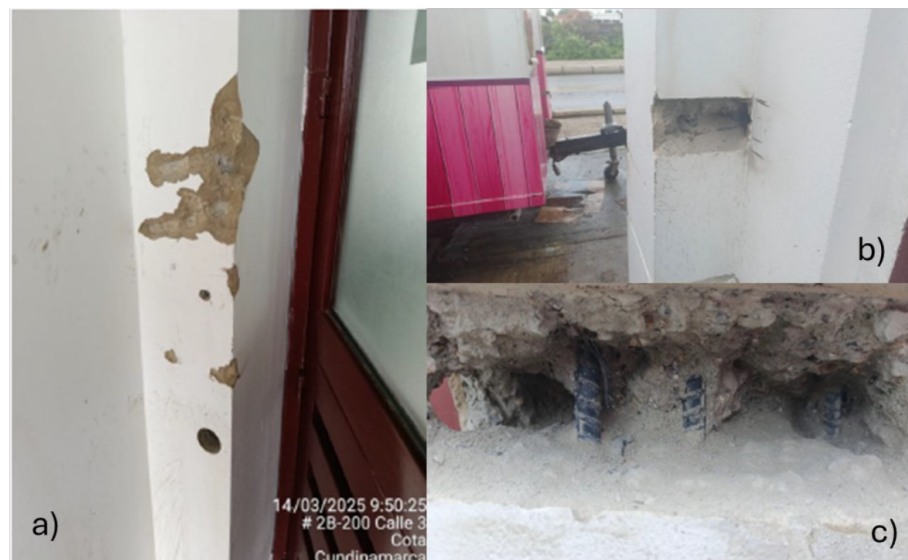
**Figure 7.** a) Corner, b) Pitting, and c) Pitting Without Corrosion

To thoroughly assess the integrity and durability of the structural reinforcement within the seismic resistance system, a series of exploratory test pits were meticulously excavated at strategically determined locations. This investigative procedure, carried out in accordance with rigorous engineering standards and best practices, facilitated direct access to the embedded reinforcing steel, thereby enabling comprehensive visual and tactile examinations. The inspection process involved detailed documentation of the physical condition, cross-sectional area, and surface characteristics of the steel bars, with particular attention to any signs of corrosion, pitting, or other forms of deterioration that could compromise structural performance. The results of these evaluations were unequivocal: no traces of corrosion or material degradation were detected in any of the surveyed reinforcement elements. This finding, as shown in Figure 7, attests to the effectiveness of the construction techniques employed and the adequacy of the environmental protection measures, reinforcing confidence in the building's long-term structural reliability and safety.

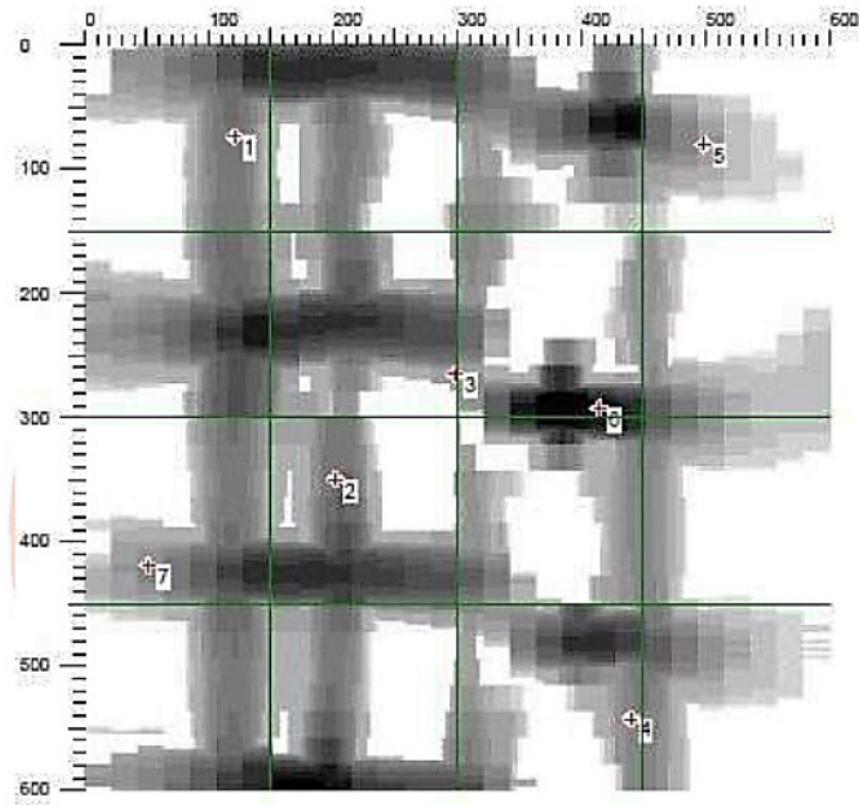
**Figure 8.** Example of a Ferroskan Test Carried Out on the Structure Under Study

This advanced diagnostic technique, grounded in the principles of electromagnetic induction, enabled precise detection of rebar positions, estimation of bar diameters, and assessment of concrete cover thickness across multiple critical sections of the structure (Table 4). The comprehensive data generated from these test points provide valuable insights into the spatial distribution, continuity, and conformity of the reinforcement system relative to the original design specifications. Such detailed analysis serves not only as a basis for evaluating compliance with engineering standards but also informs potential recommendations for maintenance, retrofitting, or further structural investigation, as required, to ensure the building's ongoing safety and performance.

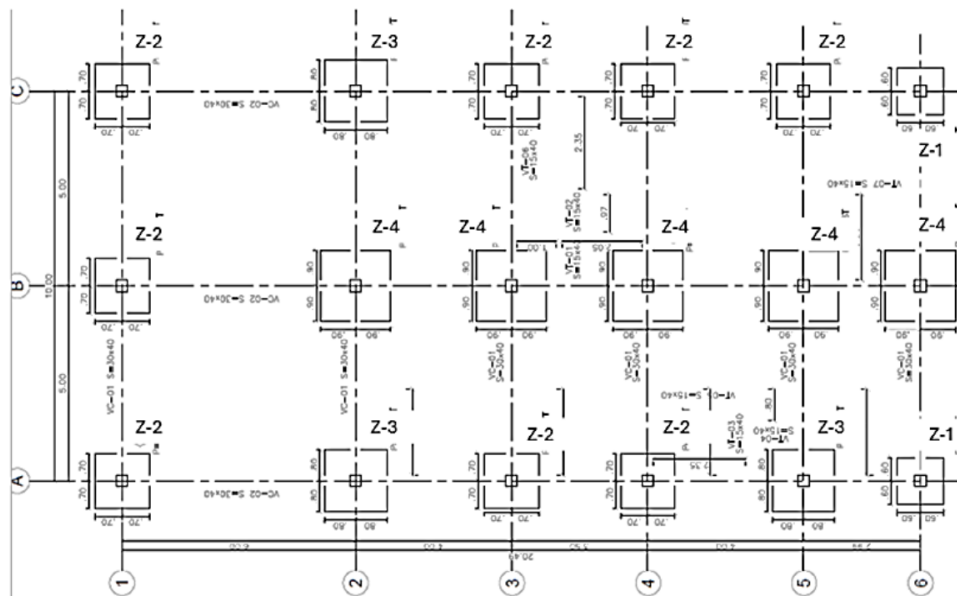
**Figure 10.** Location of Foundation Footings

According to the soil study, the bearing capacity in the study area at the existing foundation depth (1.80 m) is  $14.9 \text{ t/m}^2$ . Based on this and the modeling results, the stress index analysis was performed considering the foundation locations, as shown in Figure 10. As evidenced, the stress indices of the existing foundation are less than one; therefore, it is not considered vulnerable, and intervention is not necessary under the current conditions.
