# Capillary Pathologies in Bogota's Police Museum: Parameters and Diagnosis

**Luis Carlos Galvis-Velasco**

### Abstract

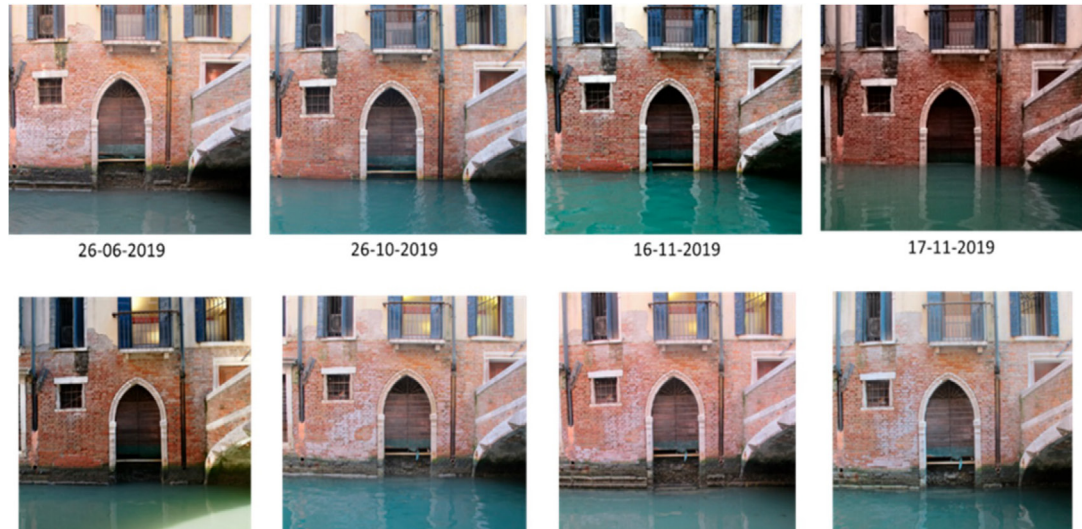
The porosity, pore-size distribution, and composition of masonry materials are intrinsic factors that fundamentally determine the extent and rate of capillary rise [19], [20]. Figure 3 illustrates the temporal variation in salt efflorescence visibility on a masonry structure in Rio dei Bareteri-San Marco (Venezia). Comparative analysis of photographs taken before (June 26 and October 26, 2019) and after (November 16, 17, and 25, 2019) the exceptional 2019 flooding event, as well as during the following spring and an extended drought, reveals the pronounced variability and environmental sensitivity of these surface deposits. As a result of this inconsistency, the presence and spatial distribution of salt efflorescence were excluded as reliable indicators for monitoring rising damp.

**Figure 3.** Photographic Record of the Masonry Structure at San Marco 556 A, Rio dei Bareteri (Calle Erizzo), Captured across Varying Time Intervals and Contrasting Climatic Conditions [20]

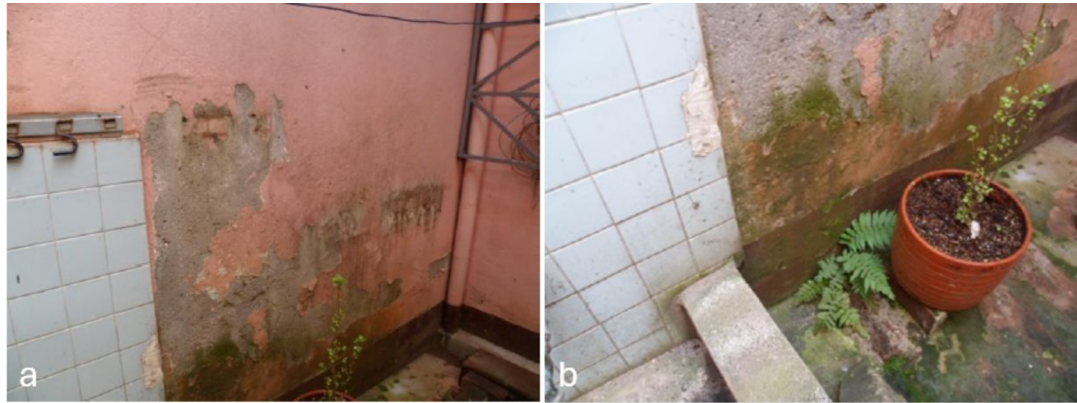
**Figure 5.** (a) Efflorescence and Mortar Cracking; (b) Bulging and Cracking of the Plaster [29]

The principal pathologies identified included differential settlement, vegetation growth near structural elements, widespread moisture ingress, efflorescence, and pervasive capillary moisture. These findings highlight the multifactorial causes of structural deterioration in regional residential buildings, emphasizing both environmental and construction-related vulnerabilities.

Several alternatives were developed to address the existing damage. The selected solution involved constructing a proper, waterproof foundation to ensure structural stability and manage settlement and ground moisture. Additionally, a wall functioning as an air chamber was proposed, incorporating a pipe and a water management filter at the base to maintain ground aeration and control capillary moisture.
