# Capillary Pathologies in Bogota's Police Museum: Parameters and Diagnosis

**Received:** 3 de junio de 2026; **Evaluated:** 17 de junio de 2026; **Accepted:** 24 de julio de 2026

**Luis Carlos Galvis-Velasco**

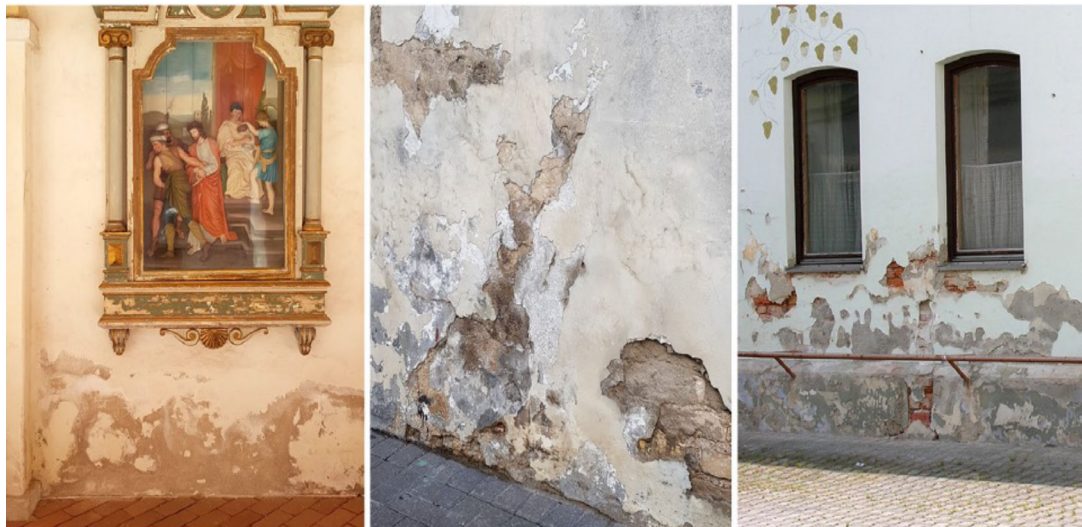
**Figure 2.** Examples of Salt Weathering and Moisture-Related Decay in Brick Masonry Substrates: (a) Poland; (b) Latvia; (c) Germany [11]

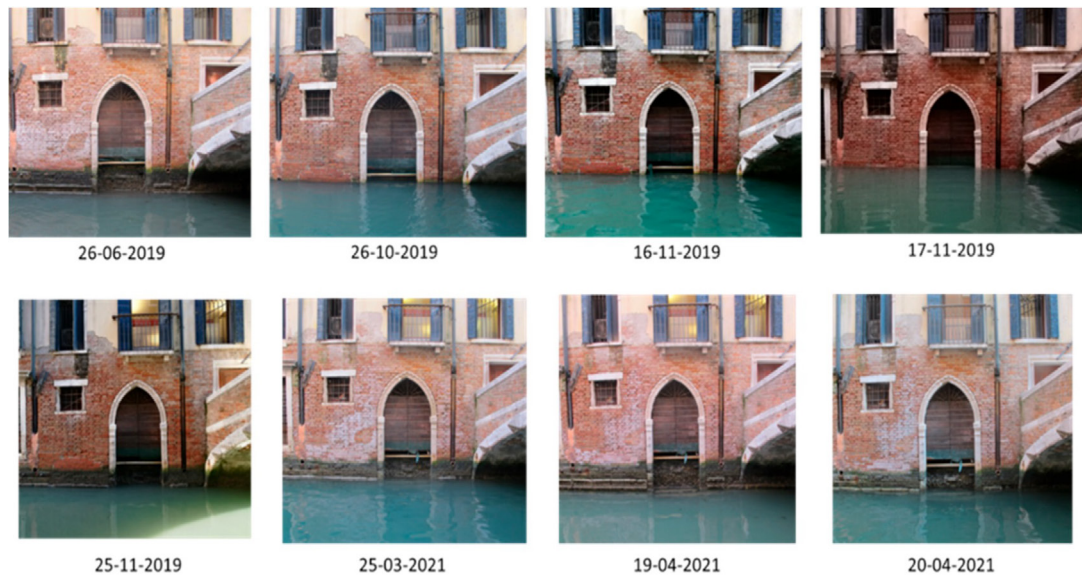
The porosity, pore-size distribution, and composition of masonry materials are intrinsic factors that fundamentally determine the extent and rate of capillary rise [19], [20]. Figure 3 illustrates the temporal variation in salt efflorescence visibility on a masonry structure in Rio dei Bareteri-San Marco (Venezia). Comparative analysis of photographs taken before (June 26 and October 26, 2019) and after (November 16, 17, and 25, 2019) the exceptional 2019 flooding event, as well as during the following spring and an extended drought, reveals the pronounced variability and environmental sensitivity of these surface deposits. As a result of this inconsistency, the presence and spatial distribution of salt efflorescence were excluded as reliable indicators for monitoring rising damp.

**Figure 3.** Photographic Record of the Masonry Structure at San Marco 556 A, Rio dei Bareteri (Calle Erizzo), Captured Across Varying Time Intervals and Contrasting Climatic Conditions [20]

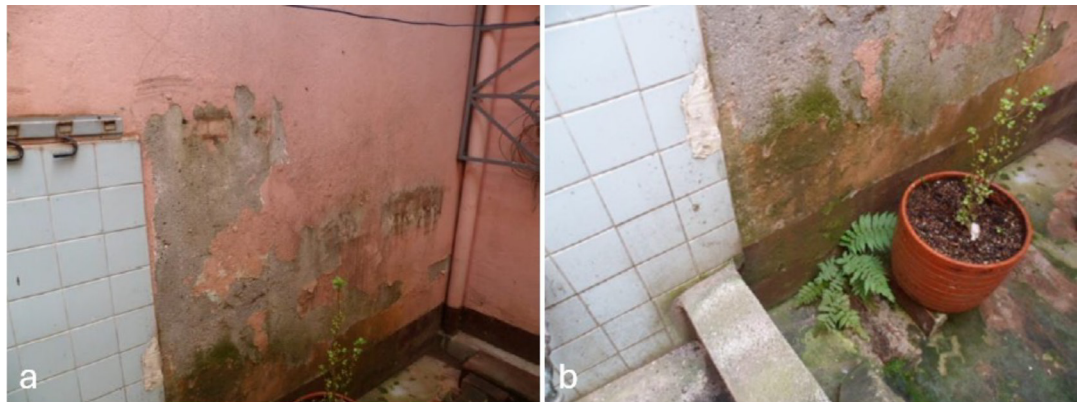
The principal pathologies identified included differential settlement, vegetation growth near structural elements, widespread moisture ingress, efflorescence, and pervasive capillary moisture. These findings highlight the multifactorial causes of structural deterioration in regional residential buildings, emphasizing both environmental and construction-related vulnerabilities.

The site surveys revealed that the structure lacks a foundation and that adequate waterproofing was not applied to prevent ground moisture from entering the building. Site surveys indicated that the structure lacks a foundation and that adequate waterproofing was not implemented to isolate the building from ground moisture, resulting in capillary moisture damage. These challenges are prevalent in similar residential structures in the region, where insufficient foundations and the absence of protective barriers against soil moisture have led to recurring settlement and water-related deterioration. Addressing these widespread issues requires improved construction

**Figure 5.** (a) Efflorescence and Mortar Cracking; (b) Bulging and Cracking of the Plaster [29]

Several alternatives were developed to address the existing damage. The selected solution involved constructing a proper, waterproof foundation to ensure structural stability and manage settlement and ground moisture. Additionally, a wall functioning as an air chamber was proposed, incorporating a pipe and a water management filter at the base to maintain ground aeration and control capillary moisture.
